DEPARTMENT OF TRANSPORTATION

Contract #: 04-0120F4Cty: SF/ALA Rte: 80 PM: 13.2/13.9File #: 69.28**WELDING INSPECTION REPORT****Resident Engineer:** Siegenthaler, Peter**Address:** 333 Burma Road**City:** Oakland, CA 94607**Report No:** WIR-018377**Date Inspected:** 25-Nov-2010**Project Name:** SAS Superstructure**OSM Arrival Time:** 700**Prime Contractor:** American Bridge/Fluor Enterprises, a JV**OSM Departure Time:** 1900**Contractor:** Zhenhua Port Machinery Company, Ltd (ZPMC), Changxing Island **Location:** Shanghai, China**CWI Name:** Zhao Chen Sun**CWI Present:** Yes No**Inspected CWI report:** Yes No N/A**Rod Oven in Use:** Yes No N/A**Electrode to specification:** Yes No N/A**Weld Procedures Followed:** Yes No N/A**Qualified Welders:** Yes No N/A**Verified Joint Fit-up:** Yes No N/A**Approved Drawings:** Yes No N/A**Approved WPS:** Yes No N/A**Delayed / Cancelled:** Yes No N/A**Bridge No:** 34-0006**Component:** TOWER & OBG Components**Summary of Items Observed:**

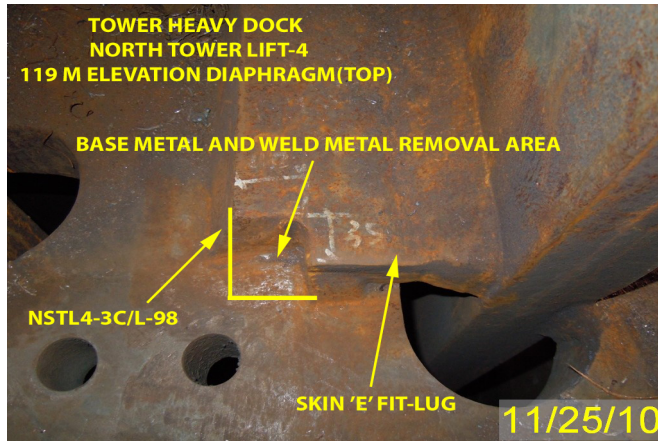
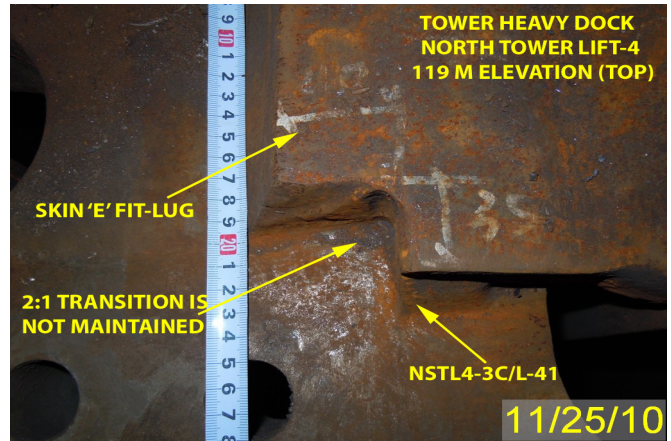
This QA inspector performed VT on lift-4 tower shafts for fit-lug plate cut-outs at 119 M elevation on North, East, West and South shafts. It has been observed that ZPMC personnel have not yet completed the repair work as per the TC-RFI-ZPM-0166R0 on North shaft. The member is identified as TOWER Component.
